Village of Homer Glen

Will County, Illinois

November 20th, 2015

# Woodbine Area Drainage Study

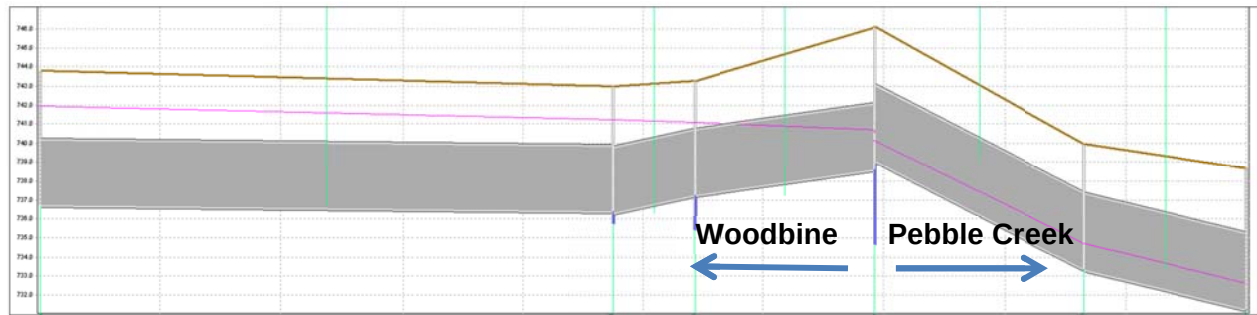
**Figure 2: Existing storm sewer profile based on survey data**

Upon inspection of the subdivision design plans and data gathered by HRG surveyors, it appears that the storm sewer system in Woodbine may have been installed incorrectly. HRG compared plans prepared by Joseph A. Schudt & Associates (JAS) dating November 1990 for the Paulnita's Subdivision, later renamed Woodbine, with surveyed storm sewer data. The pipe sizes and slopes generally matched survey data with the exception of the section of pipe within Edmond J. Sendra Park. The original design plans for the subdivision called for a 54" storm sewer at this location; however, the existing storm sewer is a 42". Additionally, this portion of pipe is heavily back pitched and it appears that this is one of the primary causes of flooding in the area. After further investigation, it appears that the reason for the backwards slope to the storm sewer is that the Pebble Creek Subdivision was constructed prior to Woodbine. It is assumed that when Pebble Creek installed the pipe for Woodbine's future connection it was installed with an invert that was too high for Woodbine to tie into. A profile of this section of pipe can be seen in Figure 2.

In order to get the most return for every dollar spent it is recommended that the Village at a minimum correct the back-pitched 42" storm sewer between Greenbrier Lane and Cricketwood drive and remove the backflow preventer in Edmond J Sendra Park. As previously noted in the Proposed Improvements section of this report, this will require replacing 392' of 42" and 48" reinforced concrete pipe (RCP) and installing new pipe with a positive slope. This small improvement will provide the most noticeable result out of all the proposed improvements. The undersized storm sewer at Eagle Ridge Drive and Cantigny Lane may be replaced to match the design plans; however this pipe is recommended to be replaced in Phase 3 and will therefore need to be replaced again. The timing of the phased implementation should be taken into consideration when determining whether or not to replace the pipes at Eagle Ridge Drive and Cantigny Lane. Phase 1 improvements are shown on Exhibit E.1a in Appendix E. Exhibits E.3a and E.3b show the resultant 10 and 100 year inundation extents if the Phase 1 improvements are completed. The anticipated cost for Phase 1 is approximately **\$321,000**.

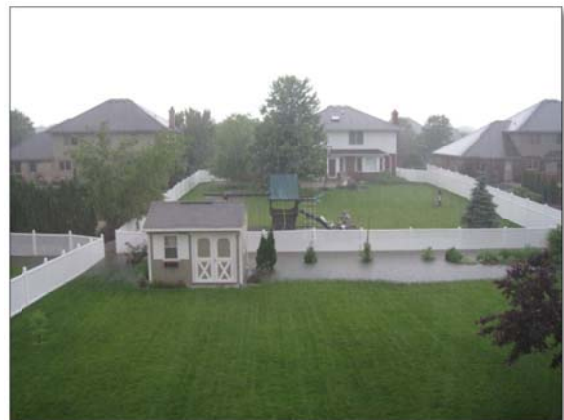
Lot 93 of the Woodbine subdivision has noted continuous yard flooding issues. This property has a catch basin located in the rear yard that was designed to collect the flows from a rear yard swale and drain it through a 12" pipe to the storm sewer system along Greenbrier Lane. According to a review performed by NIES Engineering, Inc. on July 26, 2007, adjacent properties have encroached into the drainage easements and this has increased the yard flooding issue for the residents at lot 93. This has been an ongoing issue that has been impacting multiple properties.

Lastly, the storm sewer draining Lot 93 on Greenbrier Lane should be studied in detail. It has been noted that there has been encroachment into the drainage easement surrounding a drainage structure in this area. This encroachment should be addressed or the storm sewer should be modified to accommodate the current condition of the drainage easement.

Additionally, storm sewer improvements are recommended along lot 93 in the Woodbine Subdivision. The existing storm sewer is a 12" RCP with a designed slope of 0.22% which is considered to be too flat according to current storm sewer design standards. The properties in this area have a history of rear yard flooding caused by encroachment into the drainage easement and what appears to be a storm sewer with insufficient capacity. This 184' stretch of 12" RCP storm sewer from the rear yards to the street could be replaced during the proposed Phase 1 or Phase 3 improvements. It is recommended that the replacement storm sewer be an 18" diameter at a minimum. This improvement could address the yard flooding reported by the property owners at lot 93 and adjacent properties.

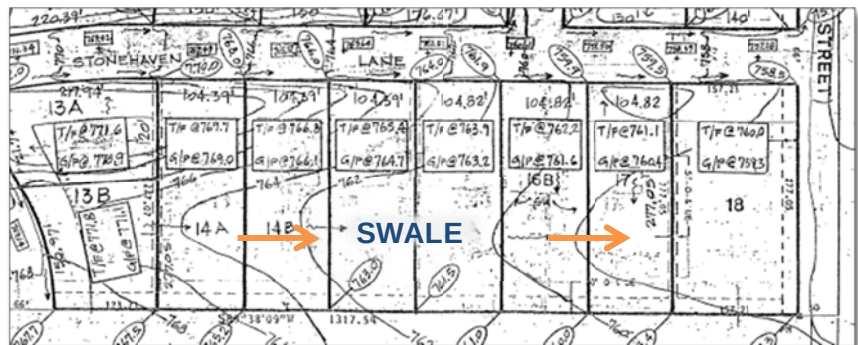
According to the original grading plan and plat dated March 27, 1990, a drainage swale was to be constructed on private property through the back yards of the homes located on the south side of Stonehaven Lane. It does not appear that there is a drainage easement in the current

location of this swale, however there is a 20' drainage and utility easement along the southern property lines. Please see Figure 5. From current (2015) aerial imagery it appears that this drainage swale has been encroached upon by multiple swimming pools and residential landscaping. This encroachment may have led to some of the reported yard flooding. Overall, this subdivision was designed to be drained via ditches along the roadway and through drainage easements. Action may be necessary to address the reported flooding in this subdivision.

It is highly recommended that a ditch and storm sewer be constructed to route offsite flows around Stadtler Ridge Estates. The ditch is expected to be approximately 980' long and be two (2) feet deep. The storm sewer is expected to be approximately 30" to 36" in diameter. The estimated cost for this drainage system is approximately **\$472,000**.

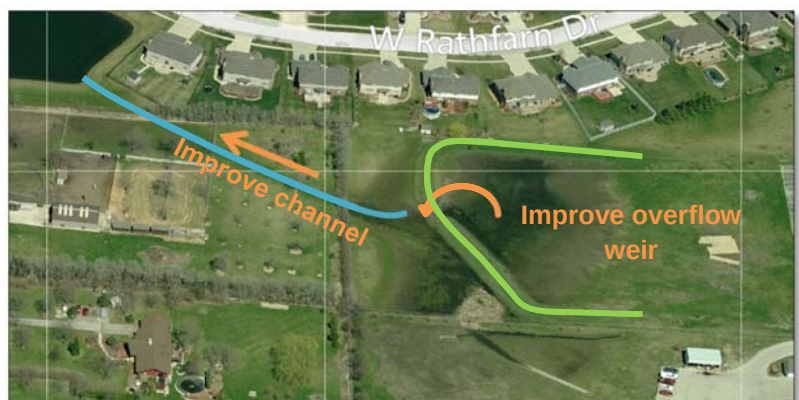
It appears that most of the drainage issues in the Woodbine West Estates subdivision are associated with the detention area between Rathfarn Drive and the HTRD building (Property PIN: 1605094000320000). According to the HTRD, there is a 12" drain tile that is located under this basin, which may be in poor condition. However, portions of this tile are located on private property

and would make maintenance of the entire tile difficult for the Village. This basin is located on land owned by Homer Township. Coordination between the Village and HTRD could take place to create a well-defined overflow and downstream channel for this basin, which would help to contain flows in the downstream channel rather than potentially flowing onto private property. Please see Figure 6.

It is recommended that coordination between the Village and HTRD take place to create a well-defined overflow and downstream channel for the basin located on the north end of the HTRD property. This would help to contain flows in the downstream channel rather than potentially flowing onto private property along Rathfarn Drive. This project is a low priority as it will address only one report of yard flooding.

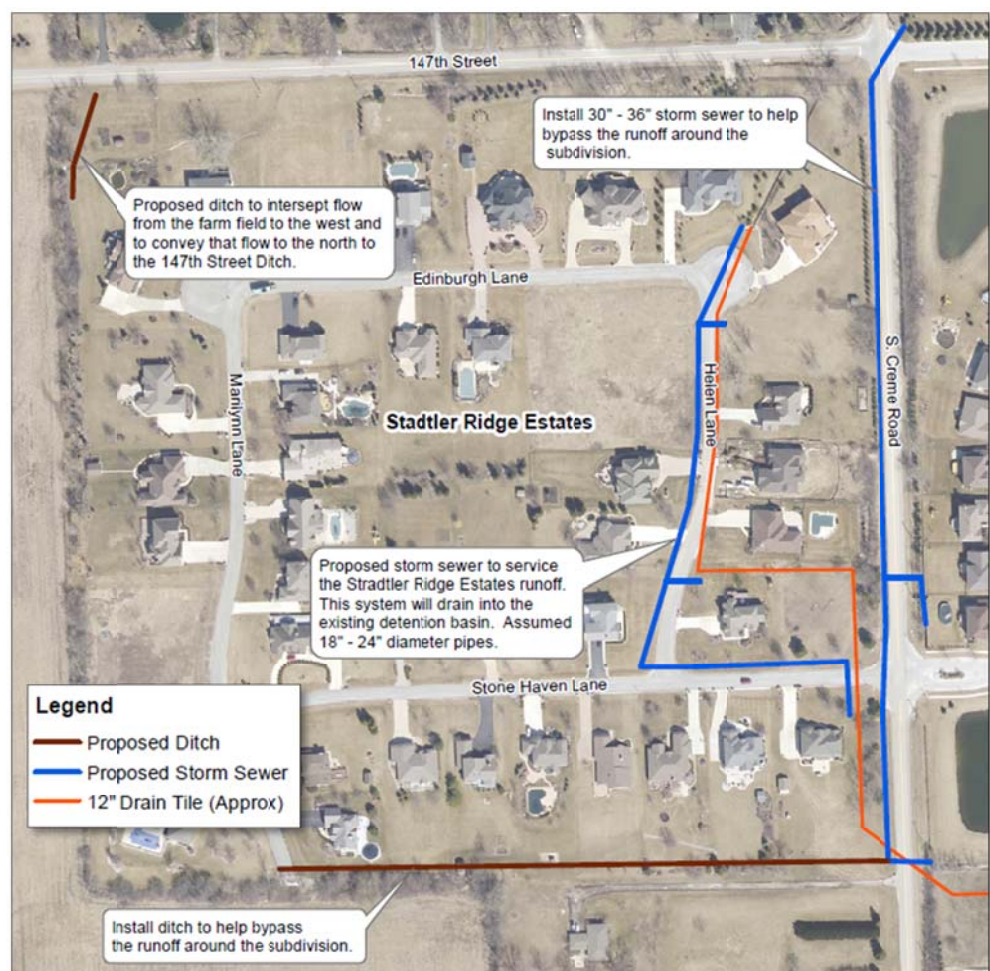
Lastly, two reports of yard flooding were received from the residents located at the northwest corner of the subdivision.

It appears that these parcels have a drainage flow path crossing through their back yards which flows from the west to the northeast into the 147<sup>th</sup> Street ditch. A solution to this yard flooding could be to intercept the flow in a ditch along the western property line and convey it to the north to the 147<sup>th</sup> Street ditch. This project may not be a high priority as there does not appear to be an immediate threat to any structures and the existing flow path. It looks like the existing channel has been landscaped to accommodate the flow through the yards. Figure 8 illustrates these proposed improvements. These proposed improvements are also shown on Exhibit E.2 in Appendix E.

Lastly, a small section of new ditch is recommended in the northwest corner of the subdivision. There appears to be a twenty foot drainage and utility easement in this location which could accommodate the ditch. This channel will help to direct offsite flows from the adjacent farm land into the 147<sup>th</sup> Street Ditch. This project is a low priority as it has the potential to help only select residents and it does not appear that there is a high risk to any structures in the existing condition. The anticipated cost of this ditch is **\$12,000**.
